Stewardship Monitoring Report

(1) Name of Property: West Monitor Barn (aka Wheeler Property)

(4) Date and Time of Inspection: 2:00pm Monday 10/22/2007

(12) Name of Monitor: Jon Kart

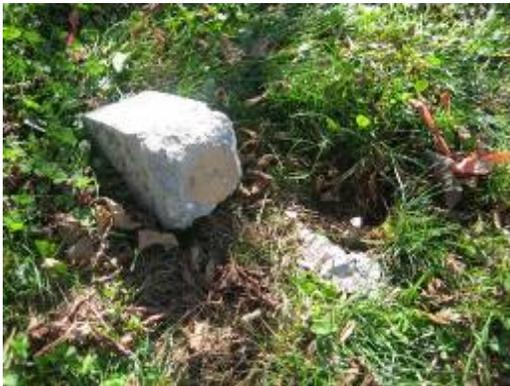
As identified in the 2007 stewardship monitoring report the survey monument engraved with the license number 695 and installed by VYCC in summer 2007 at the northeast corner of Mr. Cowles property (see site 6 in attached map) has either not been replaced or it has again been broken off. Its top was found under a nearby tree in Oct 2007 (figure 1) and immediately reported to VYCC leadership. It was supposed to have been replaced by summer 2008 but has not.

Figure 1. Broken survey monument at the northeast corner between the VYCC and Cowles properties 10/22/2007. As of 11/30/2008, the monument has not been replaced.

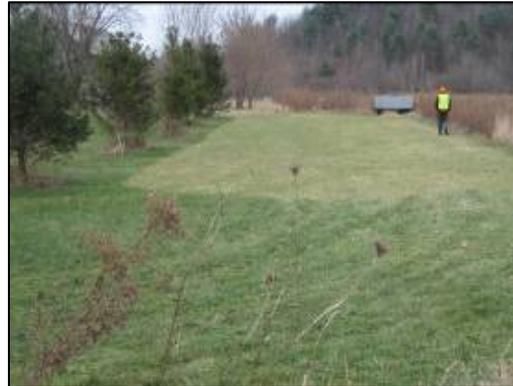
Mr. Cowles appears to continue to maintain a lawn north of the property line and north of a line of spruce trees planted to delineate the boundary (figure 2). This land could otherwise be included

in the acreage assigned to production agriculture. A vehicle trailer (most likely for ATVs/snowmobiles) is now parked north of the property line. This trailer is not the property of VYCC and should be removed immediately.

Figure 2. Encroachment on conserved VYCC property at border between VYCC and Cowles properties (to the right of the tree line). The vehicle trailer parked in this area had not been removed as of 11/30/2008.

Considering the terms of the conservation easement between VYCC and the Richmond Land Trust and Vermont Housing and Conservation Board, Mr. Cowles' previous history with boundary disputes, and his threats to take protected VYCC property via adverse possession (see 2005 stewardship monitoring report), VYCC should immediately inform Mr. Cowles in writing that he is unlawfully using VYCC lands. VYCC might discuss with RLT and VHCBC the possibility of giving Mr. Cowles a letter granting temporary permission to continue mowing the land, in order to guard against later claims of adverse possession. RLT should be copied on all correspondence with Mr. Cowles about this and related issues.

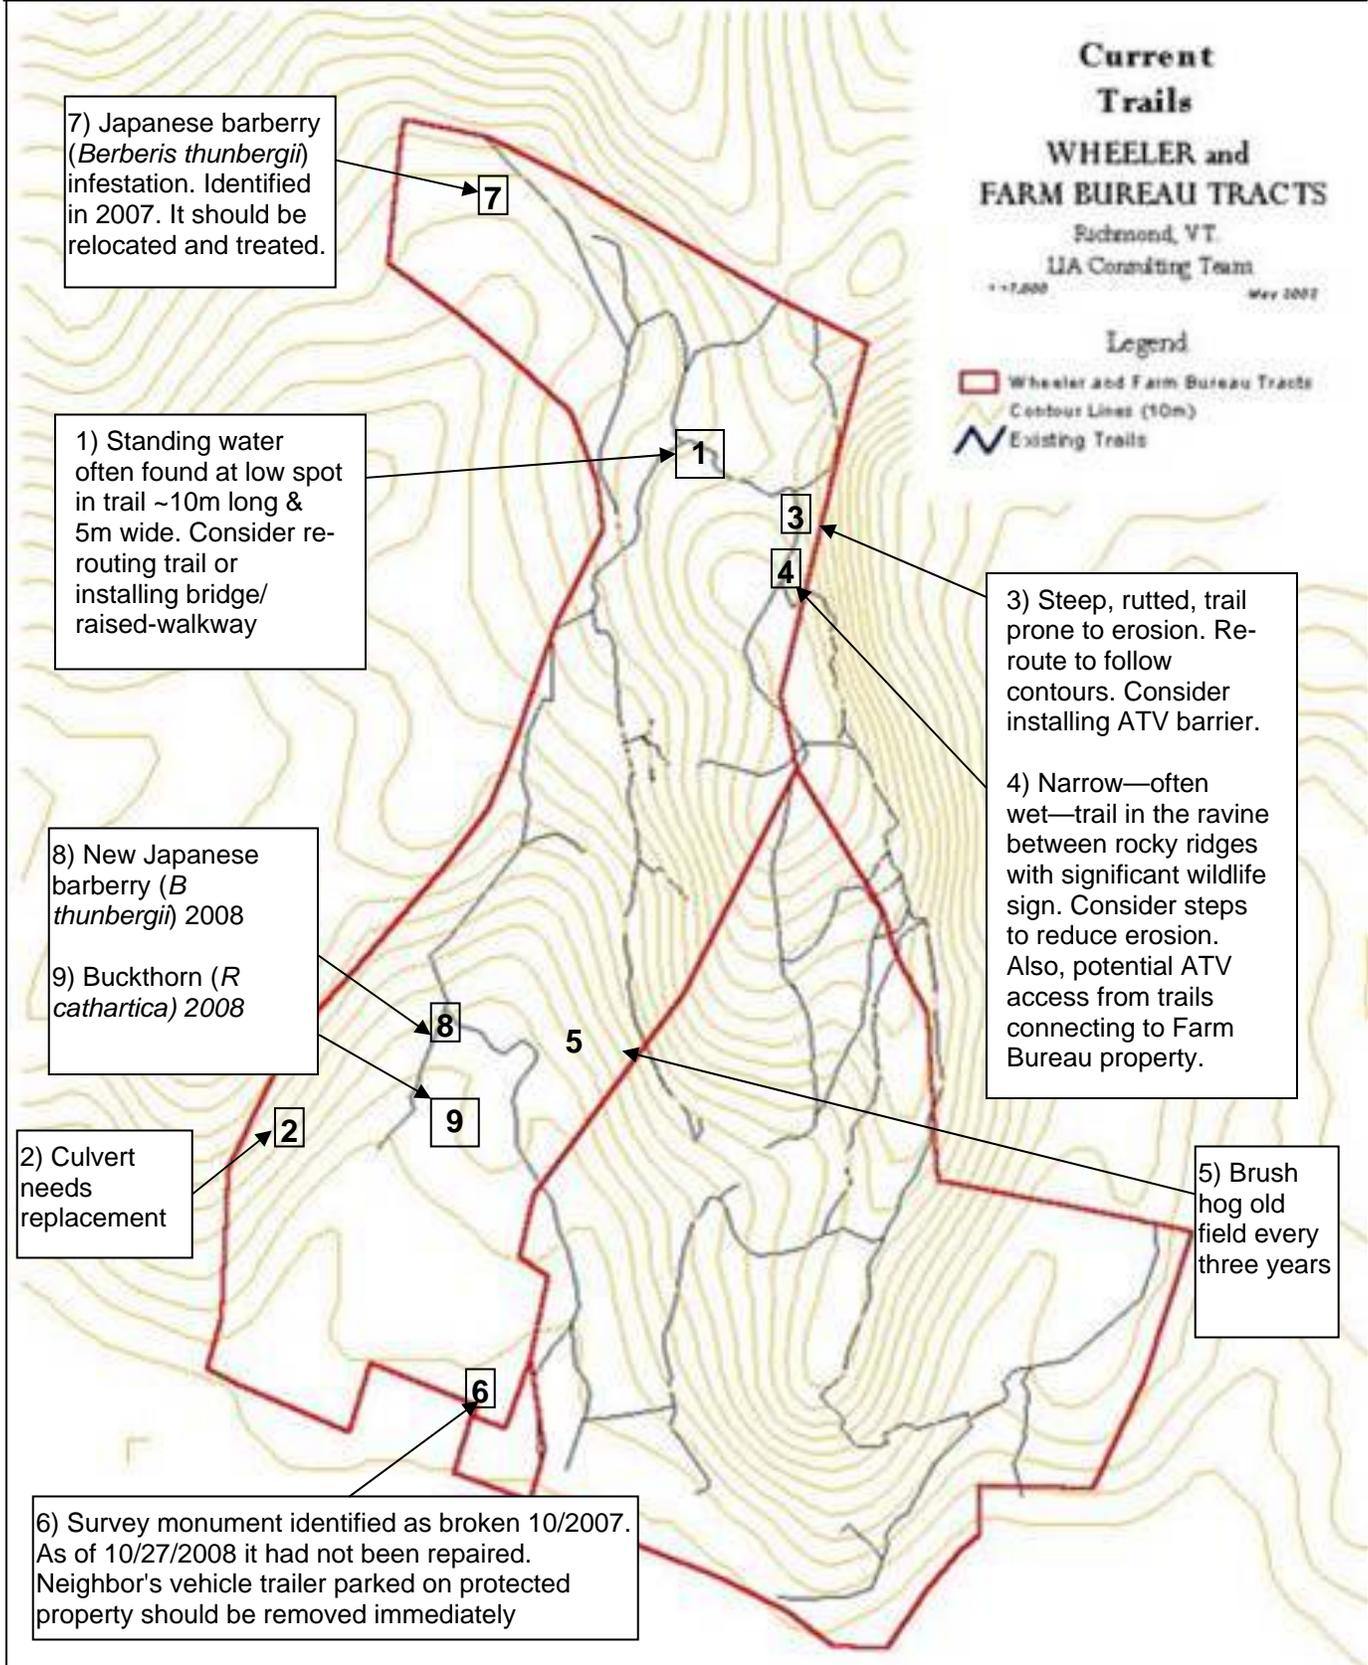
Stewardship Recommendations for the West Monitor Barn Property based on the 10/27/2008 RLT Monitoring Visit.

Repair, rerouting, and potentially decommissioning, of some trails is *still* needed at some of the locations identified in the previous, 2005-2007 stewardship monitoring reports. Repairs at these locations (sites 1-4 on attached map) are needed to restore and/or maintain forest and water quality and to prevent further soil erosion on the property. VYCC should provide a written, time-sensitive action plan for trail repair before the end of the year.

Field Maintenance: Open field areas not under agriculture should be brush-hogged every third year as stipulated in the conservation easement (sec II.2) to prevent woody vegetation to maintain the open condition. This practice should be scheduled for 2009 (area #5 on attached map).

- A) **Invasive Exotic Plants:** In 2007 the exotic, invasive shrub Japanese barberry (*Berberis thunbergii*) was found growing in the northwest portion of the property (site #7 on attached map) and the largest plants were covered with a blue tarp. As recommended in 2007, these plants and others in the area should be removed before they can spread and the surrounding area should be checked for additional plants. Follow-up monitoring should occur for two-three years to ensure that dormant seeds haven't sprouted. The infestation could not be found during a survey in the summer of 2008. VYCC should inspect this area again during winter 2008/early spring 2009 before leaf out to re-find the infestation and to record GPS points.

In 2008 Bradley Materick, VYCC Land Stewardship Specialist, identified another Japanese barberry site and the presence of buckthorn (*Rhamnus cathartica*), an invasive exotic tree on the property (site #8 and 9 on attached map). Actions were taken immediately to remove these plants. The locations should be monitored for the next two-three years to ensure the plants do not re-sprout.
