# Stewardship Monitoring Report

(1) Name of Property: **Wheeler Preserve and Monitor Barn**

# Trail Recommendations for Stewardship Monitoring Report 10/29/2006 for Monitor Barn Property.

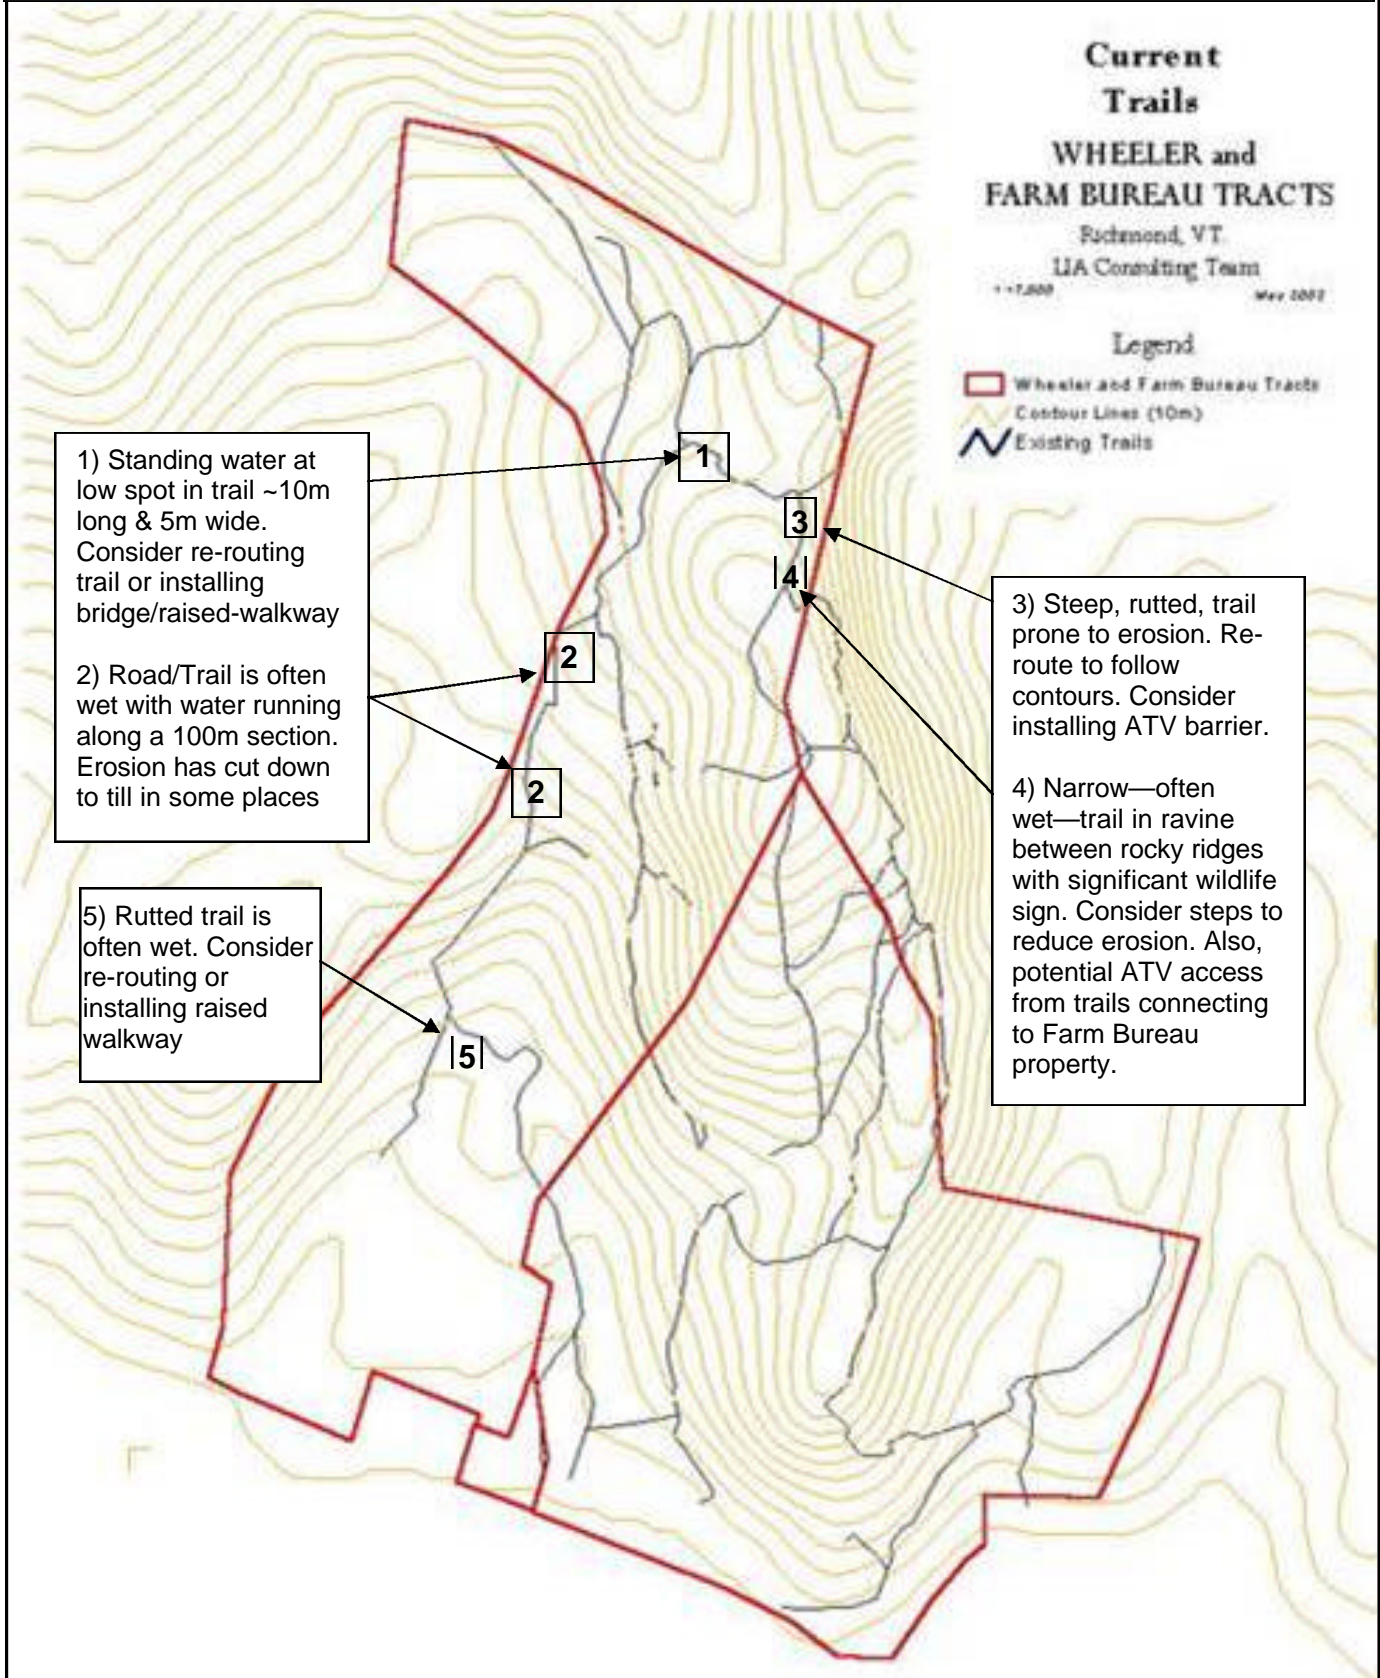
Running and standing water on a number of trails is causing excessive erosion and the development of social trails. A trail management plan should be developed for the Wheeler Preserve (e.g. which trails to maintain, which to close, which to re-route). This plan could include an updated assessment of trail condition and should precede trail work. See the baseline report by LIA Consultants for a map of trails and trail condition and trail management recommendations.
