Stewardship Monitoring Report

(1) **Name of Property:** West Monitor Barn

(4) **Date and Time of Inspection:** Wednesday 11/11/2010, 8am-10:30pm

Stewardship Recommendations for the West Monitor Barn Property 2010.

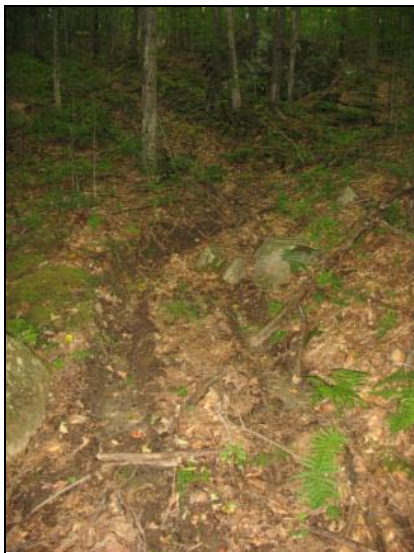
ATV use, however, has increased on the conserved land (see Recreational ATV Use on the attached map) and there is evidence of trail widening and trail clearing for recreational ATV usage. Just outside of the conserved parcel ATV tracks were found in and across streambeds and sensitive and wet soils (figure 1) and on lands owned by neighboring property owners (figures 2 and 3) accessible only through VYCC property. VYCC staff and leaders were made aware of ATV use on the property on September 1, September 23 and October 15 of this year. Despite this lead-time, the VYCC representatives that accompanied me on the monitoring tour reported not knowing who the ATV operator(s) is nor who did the trail widening.

Figure 1 ATV tracks in streambed

ATV's have been seen crossing Route. 2 and onto the East Monitor Barn parcel. It appears that the ATV's are then accessing the West parcel from the adjacent East Monitor Barn parcel. It is highly recommended that neighboring property owners whose lands have been impacted by ATV use and associated trail clearing be notified immediately. The installation of locking gates, log barriers and appropriate signage are recommended as first steps to curtail this problem.

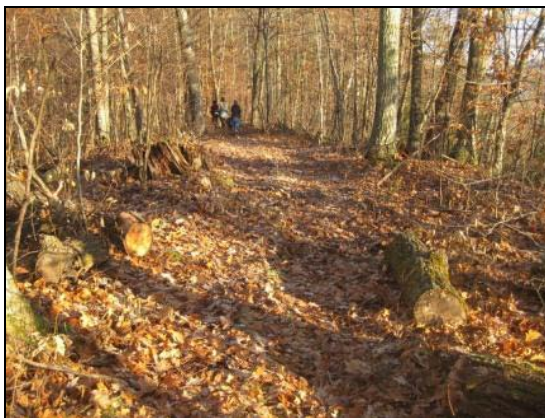
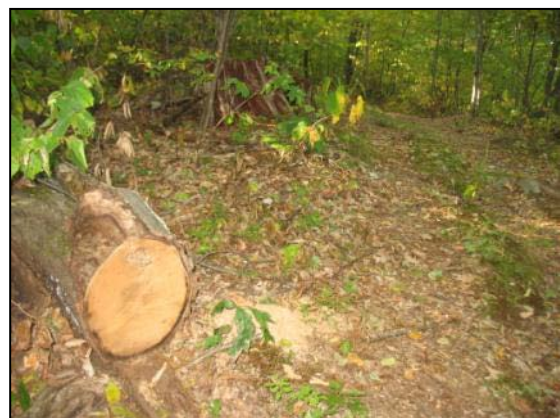
Figures 2 and 3 Trail clearing for Recreational ATV usage on neighboring properties

VYCC staffers have suggested that trading recreational ATV access to the property was offered to a neighboring property owner in exchange for brush-hogging and other land management services, and in an effort to maintain neighborly relations. Recreational ATV usage is not allowed according to easement language and is therefore not a good or service that VYCC can offer to the neighbor.
